Journal of Engineering Research and Reports

Die Attach Pre-bond Inspection Innovation for Roughened Leadframe

Short Research Article

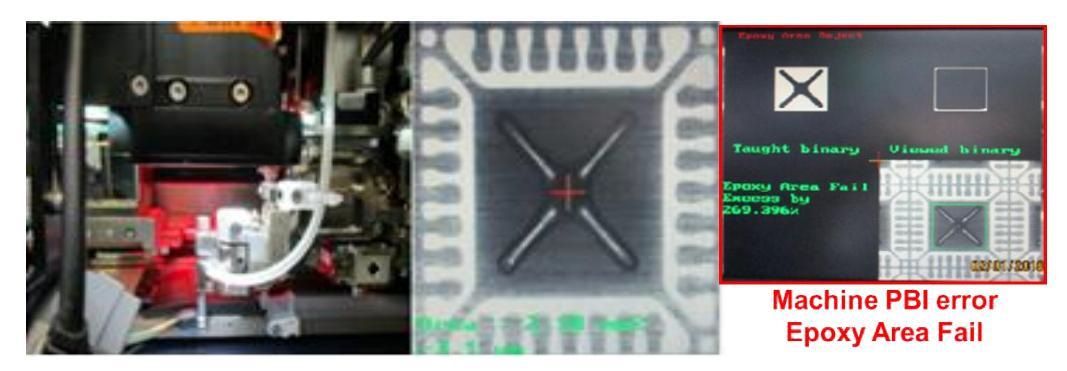
The study on the roughened leadframe utilizing the Pre-bond parameter for Ag-based epoxy on standard Ag-plated DAP Cu leadframe causing Pre Bond-Inspection Machine cannot fully detect the epoxy pattern, due to dark background image cause by rough leadframe, as shown in Fig. 1.

Fig. 1. Die attach pre bond-inspection machine cannot fully detect the epoxy pattern due to roughened leadframe

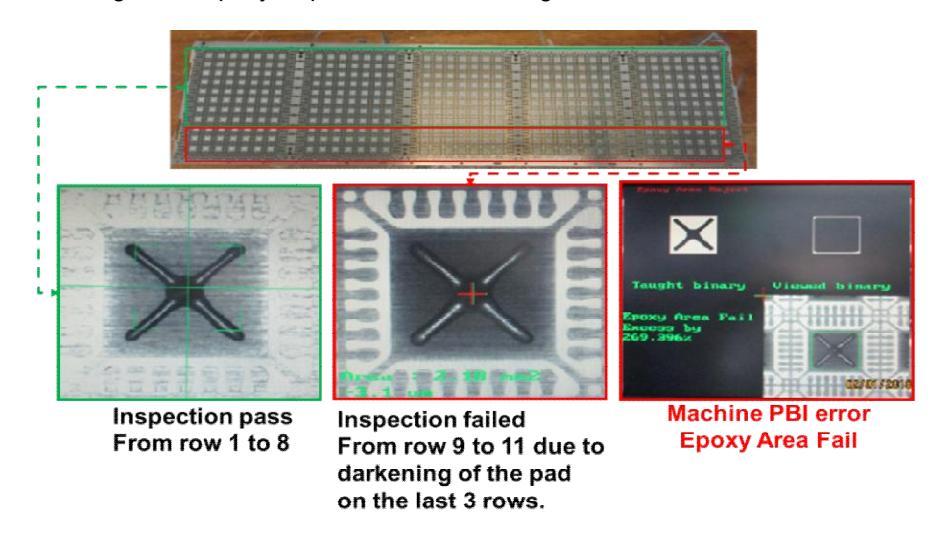
The uneven contrast of pad's, causing pre-bond inspection problems as shown in Fig. 2. From row 1 to 8 the inspection show passed result, while the remaining 3 rows from 9 to 11 show PBI error failed due to the darkening of the pad. Hard to teach / set-up epoxy inspection due to no contrast between leadframe die pad vs. epoxy. Roughen leadframe property has different surface contrast causing Frequent "Bond Align" and epoxy inspection error on Roughen leadframe.

Fig. 2. Roughened leadframe causing die attach pre bond-inspection error, cannot fully detect the epoxy pattern
